Poor House Run Hydrologic Assessment and Watershed Action Plan

April 1, 2022

Appendix E: Constructability Analy	ysis

POORHOUSE RUN STREAM RESTORATION CONSTRUCTION FEASIBILITY REPORT

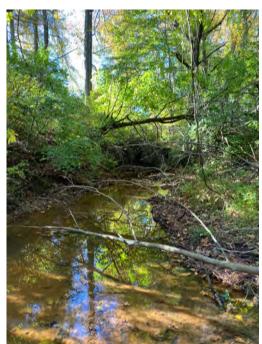
Photo 5. Phase 3 - Poorhouse Run Stream Channel

The topography within the bounds of phase 3 varies significantly throughout the proposed work area. Access is not available to the right bank from the north for a majority of the project area length due to steep slopes and residential lots. The left bank has only a few location where the slopes are traversable. Of those slopes, even fewer outlet to a floodplain location with a landing. The majority of the steep slopes run directly to the stream channel which would not support vehicular access.
