# Poor House Run Hydrologic Assessment and Watershed Action Plan

April 1, 2022

ShoreRivers  
114 S. Washington Street  
Easton, MD 21601  
443-385-0511  
info@shorerivers.org  
www.shorerivers.org

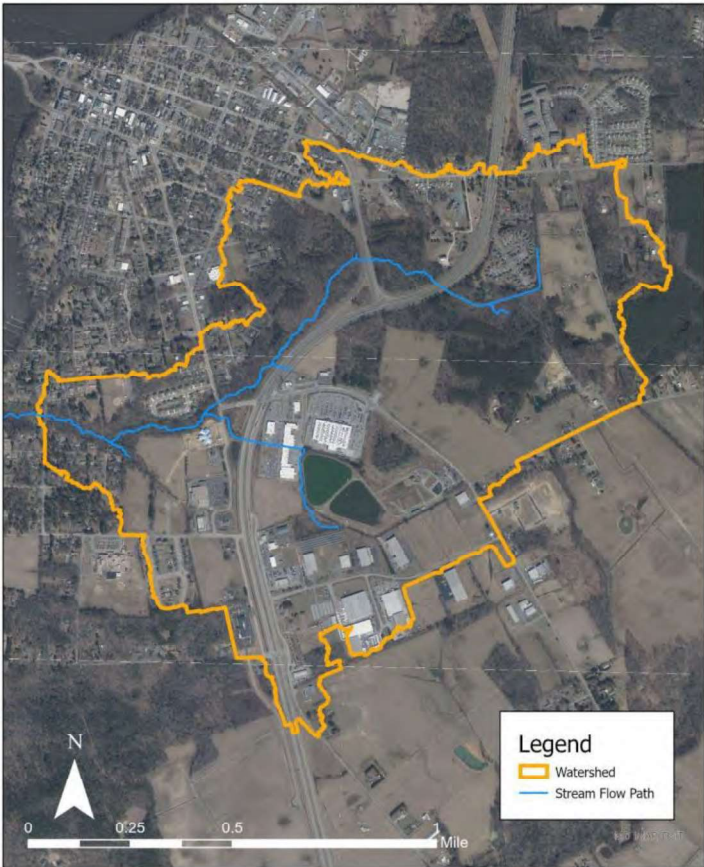
**Figure 1. Poor House Run Watershed**

There are two main tributaries that meet just west of South 5th Avenue. One stream flows from the northeast, and the other flows from the southeast. The northeast tributary is mostly residential and forested, and the southeast tributary is predominantly commercial and includes the Denton wastewater treatment plant.

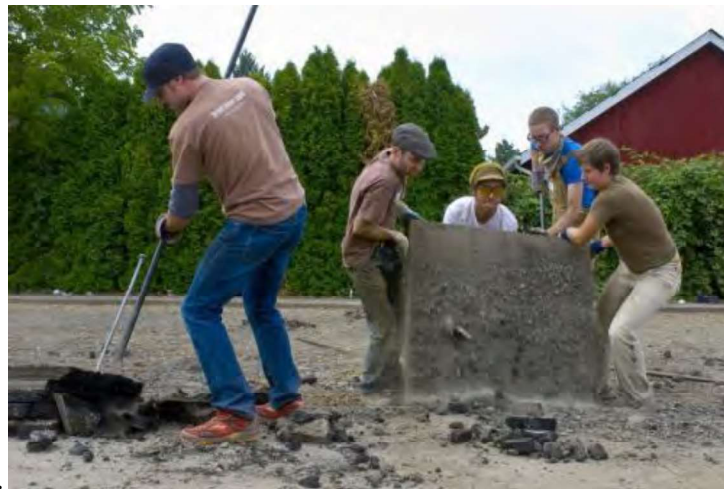
**Figure 3. Depave, a non-profit from Seattle, WA, organizes volunteer groups to manually remove impervious surfaces.**

Efforts to remove unnecessary or failing impervious surface areas are being undertaken all around the Chesapeake Bay watershed, and range in capacity from volunteer community groups to local government capital improvement projects. Prime areas for impervious surface removal include unused parking lots, deteriorated walkways, and other areas that can be used for green infrastructure stormwater management projects

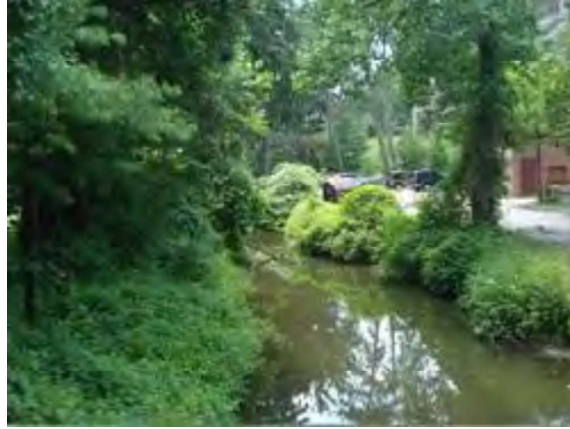
**Figure 4. Forest buffer alongside an urban stream in New York.**

*Urban Forest Buffer* – Forest buffers are used in urban areas where stormwater has the increased potential to travel and transport pollutants as surface runoff. Urban forest buffers refer to areas where collections of trees are planted to help buffer a local waterway from surface runoff, or a location that separates two or more densely paved areas. In general, urban tree canopy (UTC) provides an important stormwater management function, and can be a valuable tool in filtering and absorbing water, which would otherwise add stress to stormwater systems.

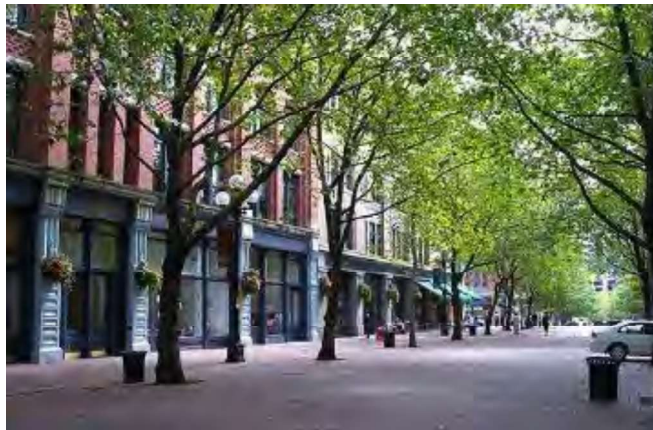
**Figure 5. Street trees along an urban center.**

*Urban Tree Planting* – Urban tree planting refers to city/town-scape, street tree plantings that are arranged throughout town’s roadways and residential and business properties. This practice is different from urban forest buffers in that the plantings aren’t necessarily buffering a waterway or large amounts of impervious surfaces. Urban tree plantings are considered the fillers in a town’s urban tree canopy. In addition to providing stormwater management benefits, they also reduce the urban heat island effect, decrease heating and cooling costs, lower air temperature, reduce air pollution, increase property values, and provide wildlife benefits. The business park along Engerman Ave. would benefit from street trees.

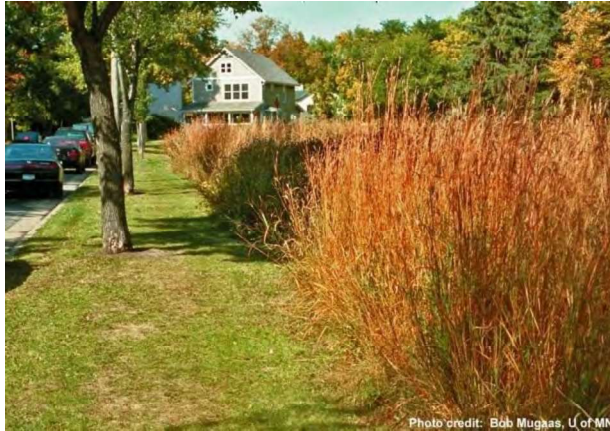
**Figure 6. Urban grass buffer example showing tall grasses buffering a paved area.**

*Urban Grass Buffer* – Similar to urban forest buffers, grass buffers act as a filter that captures and absorbs runoff. Urban grass buffers include a diverse mixture of warm and cold season grasses that are allowed to grow tall, while their roots grow deep into the soil. Urban grass buffers should be maintained and cut once or twice a season in order to keep out undesired and invasive plants, but the area should not be maintained as often as typical residential lawn.

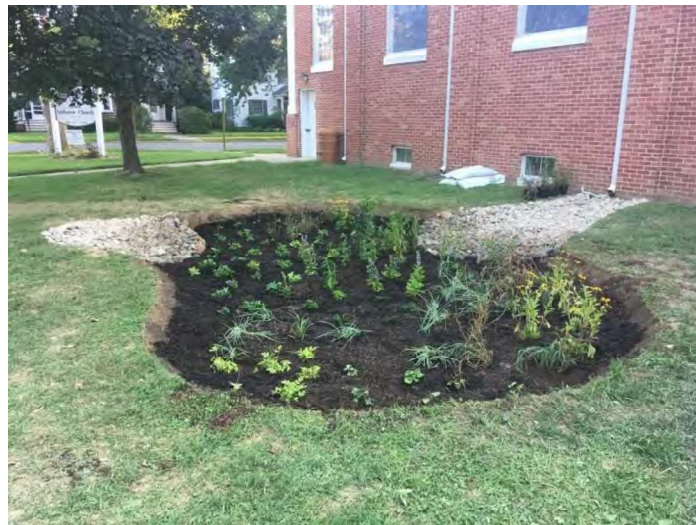
**Figure 7. Bioretention project at a local church in Easton, MD**

*New and Retrofitted Bioretentions* – Bioretentions are stormwater treatment facilities that capture and temporarily store runoff. Once it enters the BMP area, the water is slowly released and passed through a filter bed of sand, organic matter and soil, often referred to as a bioretention mix. Depending on the design, the filtered runoff may continue to filter into the groundwater, or may be returned to the stormwater conveyance system via an underdrain. The treatment areas are typically planted with native grasses and plants that help to filter out any pollutants, as well as provide aesthetic and habitat benefits to the practice. Native pollinator plants are often used to attract butterflies and other beneficial pollinator species.

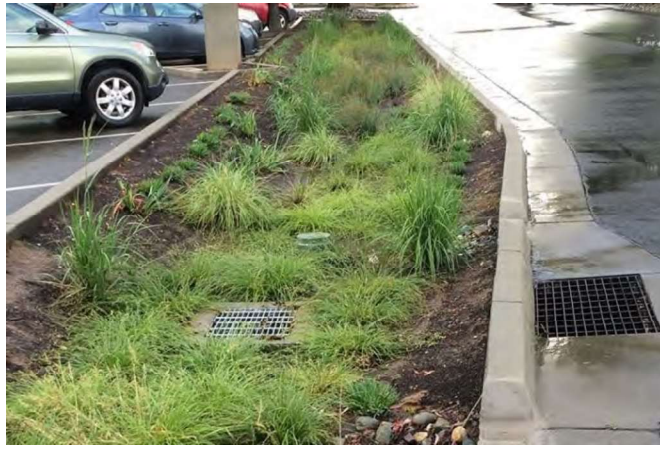
**Figure 8. A bioswale on the campus of California State University**

*Bioswale* – A bioswale is a landscape BMP that is designed to remove nutrients and sediment while transporting rainwater. A bioswale typically consists of a soil medium that includes sand, organic matter like compost and soil, native vegetation, sloped banks, and sometimes riprap. Depending on the landscape, bioswales can be meandering or straight, and the amount of time

that water stays within the channel is maximized up for 24 hours to allow for sufficient nutrient and sediment removal.

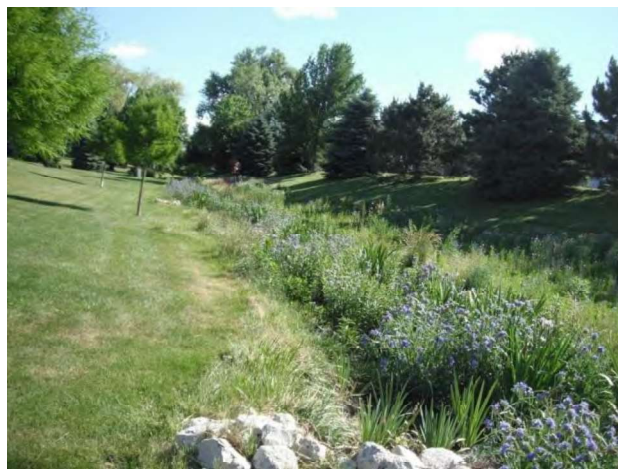
**Figure 9. Example of vegetated open swale in Maryland.**

*Vegetated Open Channels* – This practice is similar to a bioswale in that it is used to remove nutrients and sediment as water is transported through a channel. Unlike bioswales, vegetated open channels do not necessarily include the same soil medium that consists of organic matter and sand, but they do include native vegetation and sloped banks, and sometimes riprap as needed. Vegetated open channels are a less expensive alternative retrofit option than a bioswale, and can be very effective given the amount of insufficiently vegetated open channels throughout the Poor House Run watershed.

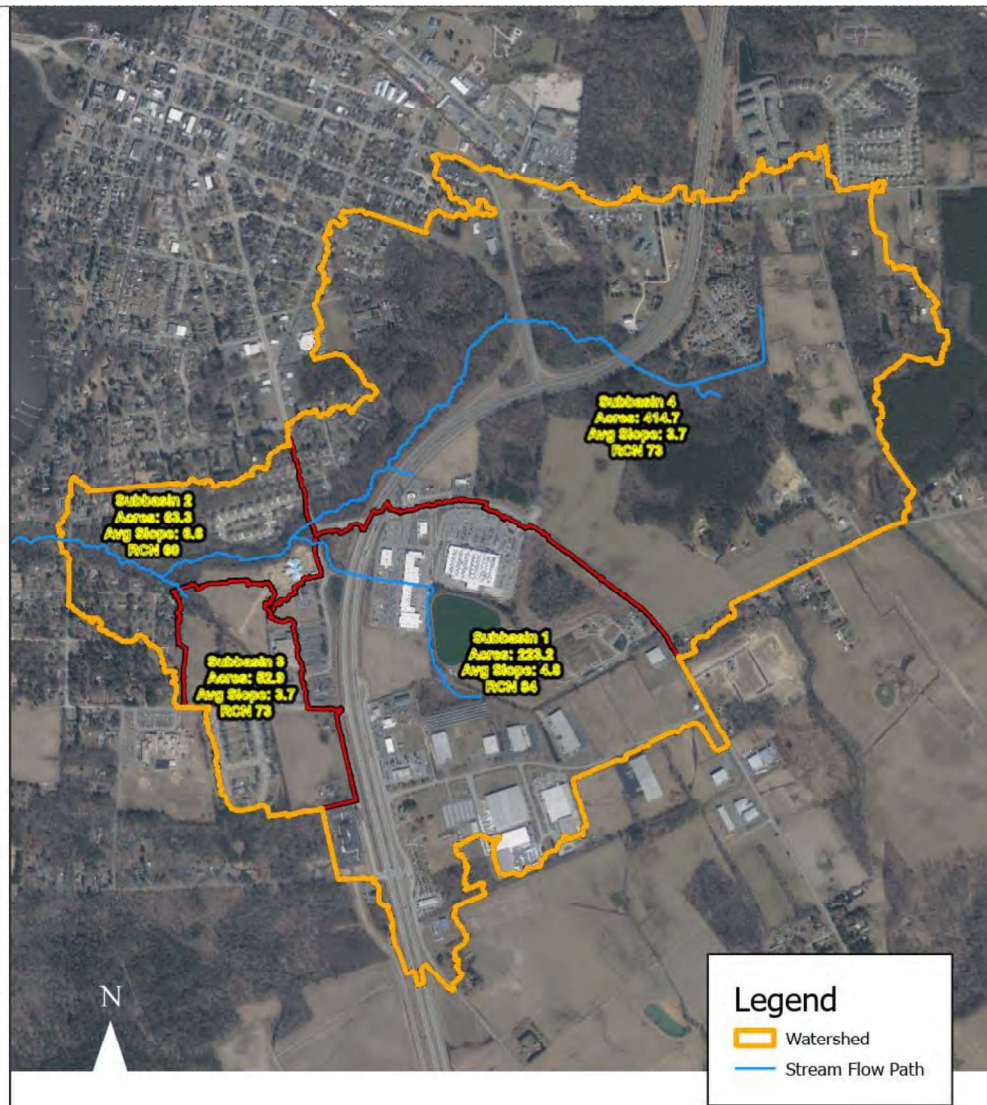
Figure 11. Sub-basins within the Poor House Run watershed that were used for the hydrologic analysis

The entire catchment area was subdivided into four sub-basins, representing three main inflows to the stream and the area adjacent to the main stream corridor.

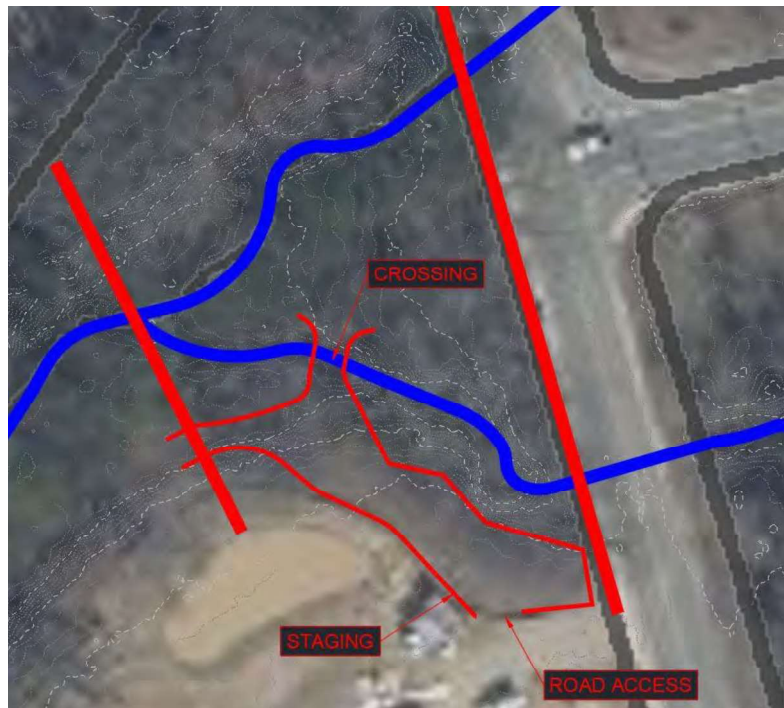
Figure 15. An example from the constructability analysis of access and staging areas near the Choptank Health complex

1. The stream restoration should be completed at the same time of the culvert replacement at 5th Street because it provides greater accessibility options and reduces traffic issues.
2. The best access to Poor House Run is through the northeast side of the Choptank Community Health complex and Food Lion parking lot, and across the Town Park.
3. The Choptank Community Health complex and the Town Park provide the best staging areas for equipment and materials.
