**REQUEST FOR PROPOSALS TO PROVIDE PROFESSIONAL SERVICES  
FOR WETLAND AND STREAM RESTORATION, CONSTRUCTION PLANNING, AND DESIGN SERVICES  
Date of Advertisement: April 1, 2024 / Deadline for Receipt of Proposals: April 26, 2024**

**ShoreRivers seeks qualified vendors to provide professional services for design/build of a wetland restoration and stream restoration site in southern Cecil County, MD.**

**DRAINAGE AREA MAP**  
**CECILTON FARM WETLANDS PH II**  
 PREPARED FOR CBT WAGP  
 MARYLAND  
 CECIL COUNTY

## Cecilton Farm Phase II – Site Condition Photos

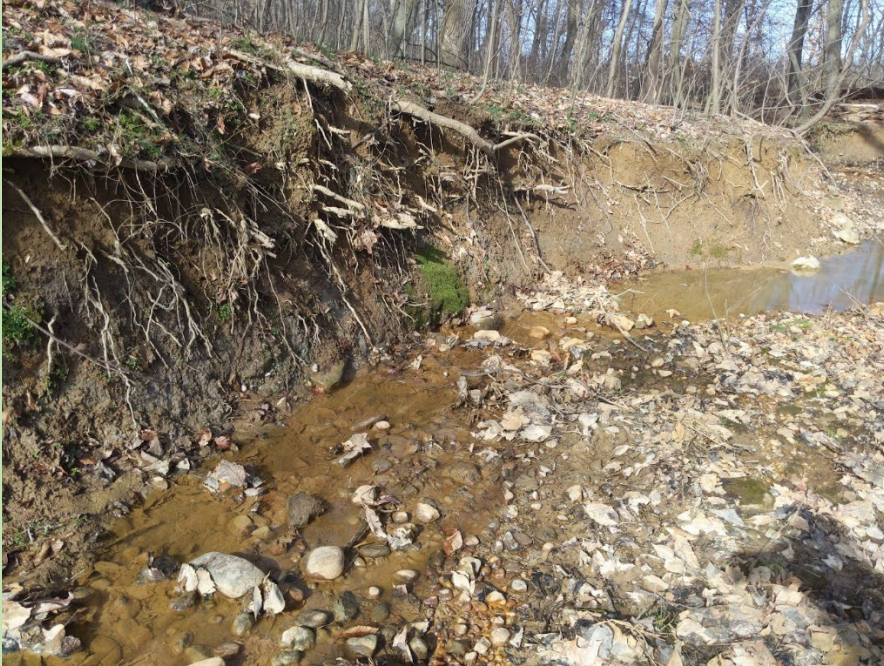
Typical laterally eroding bank

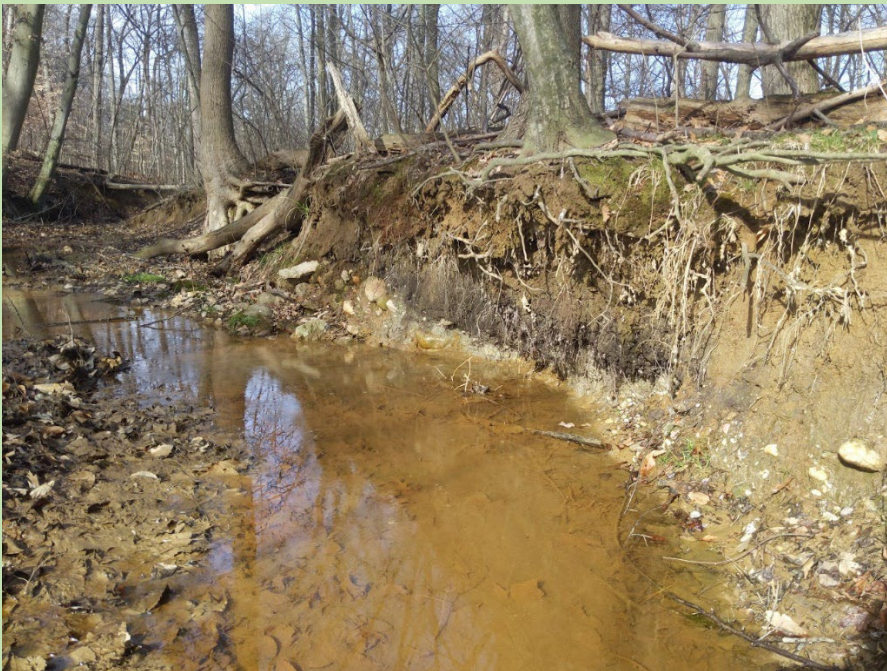
Undercut tree on collapsing bank

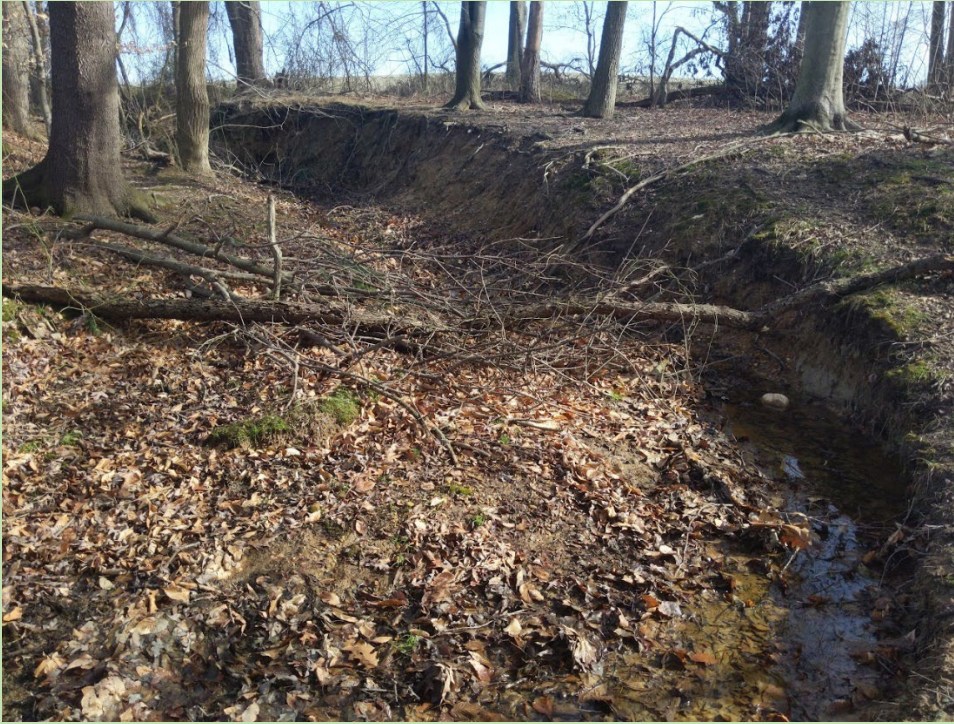
Headcut migrating toward field edge

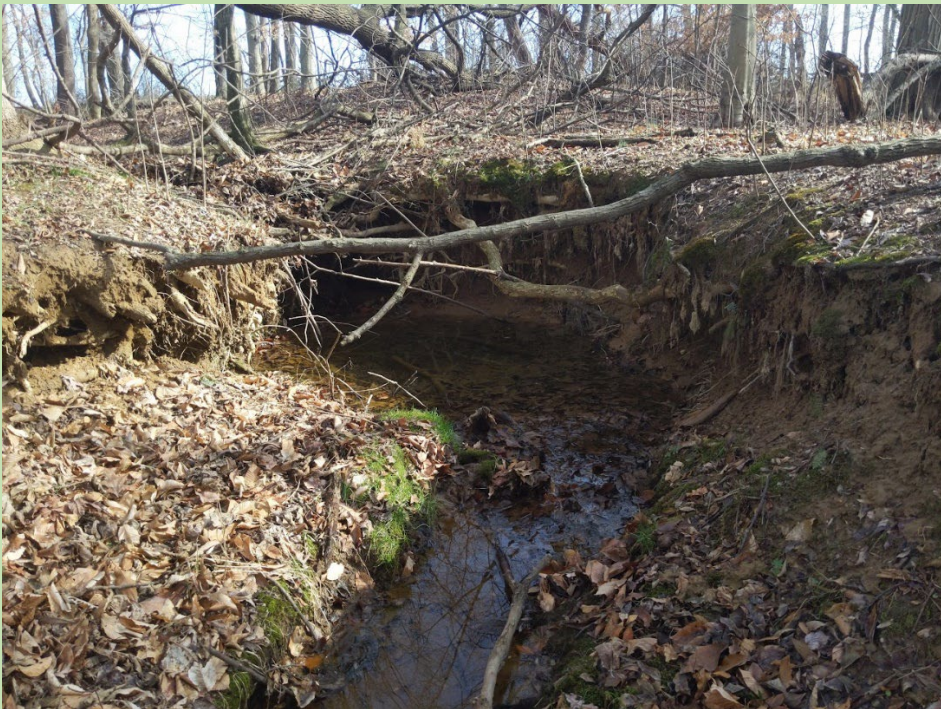
**Headcut migrating toward field**

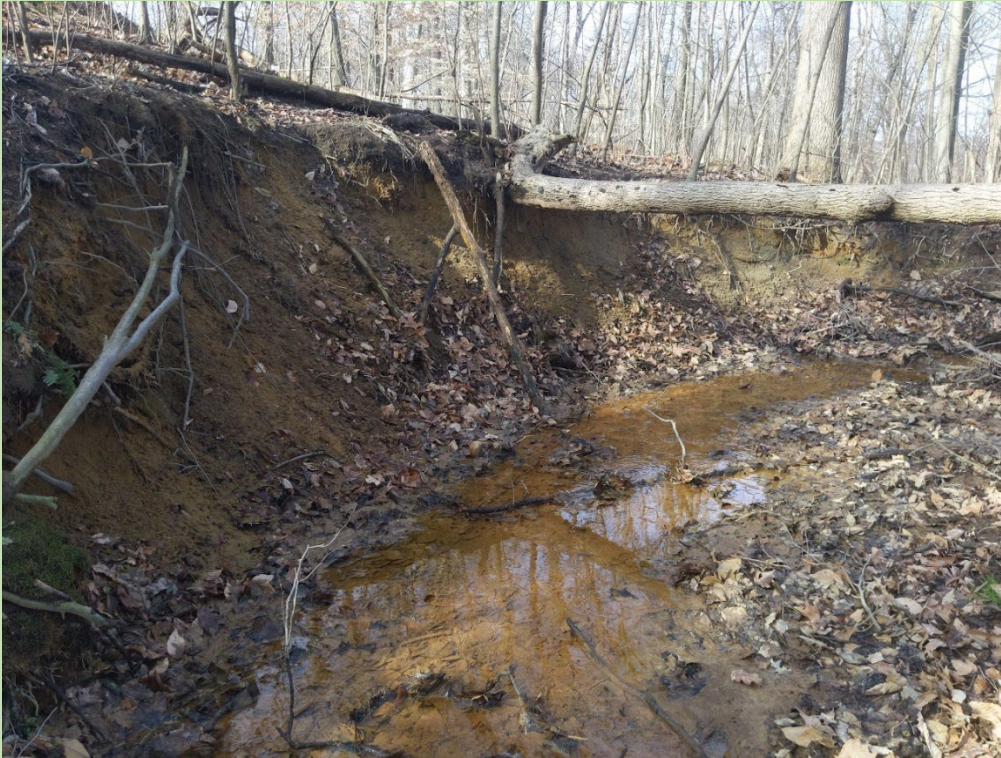
**Eroding outer meander bed- 5 to 6 ft bank height**

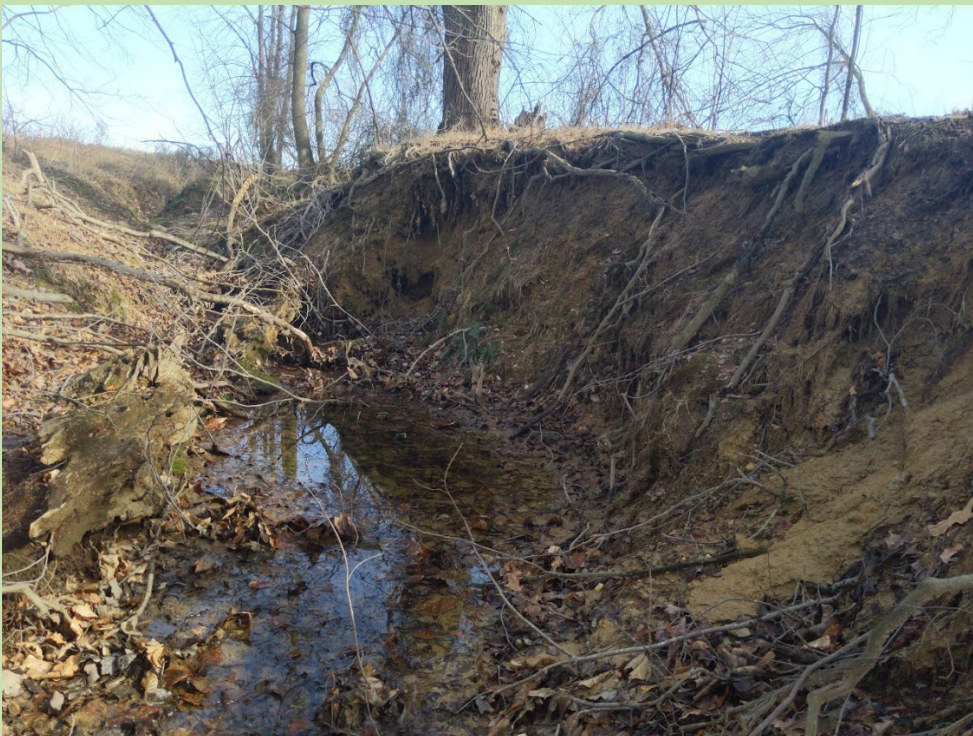
**Headcut migrating toward field edge through woods**

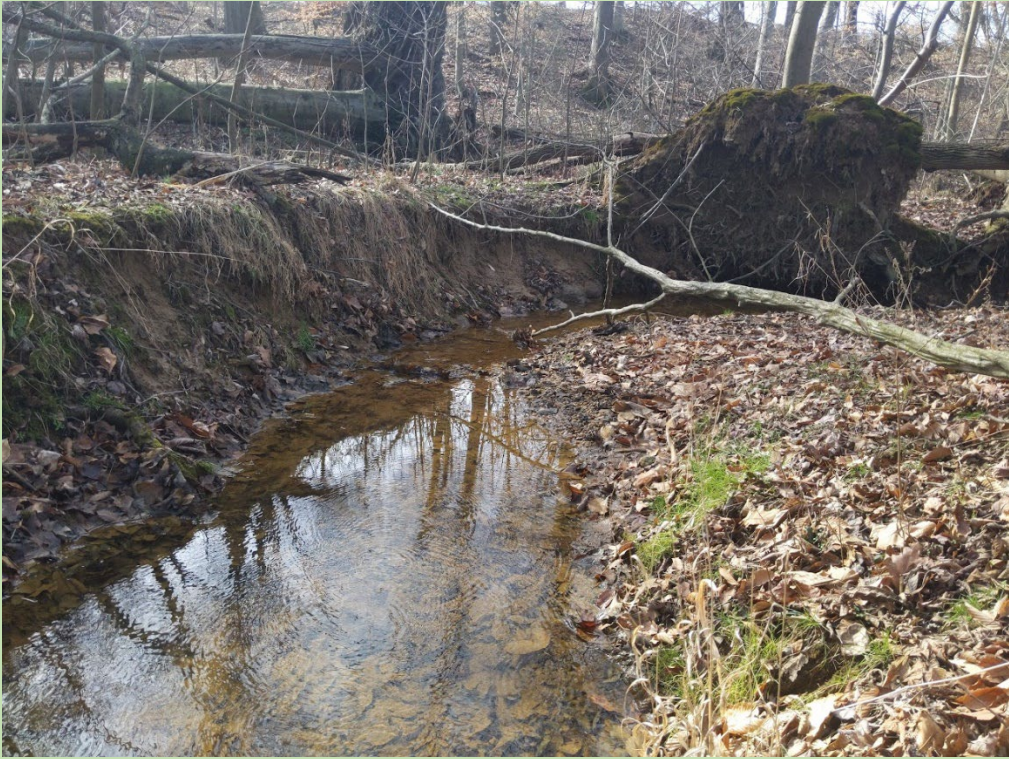
**Eroding outer meander bend**

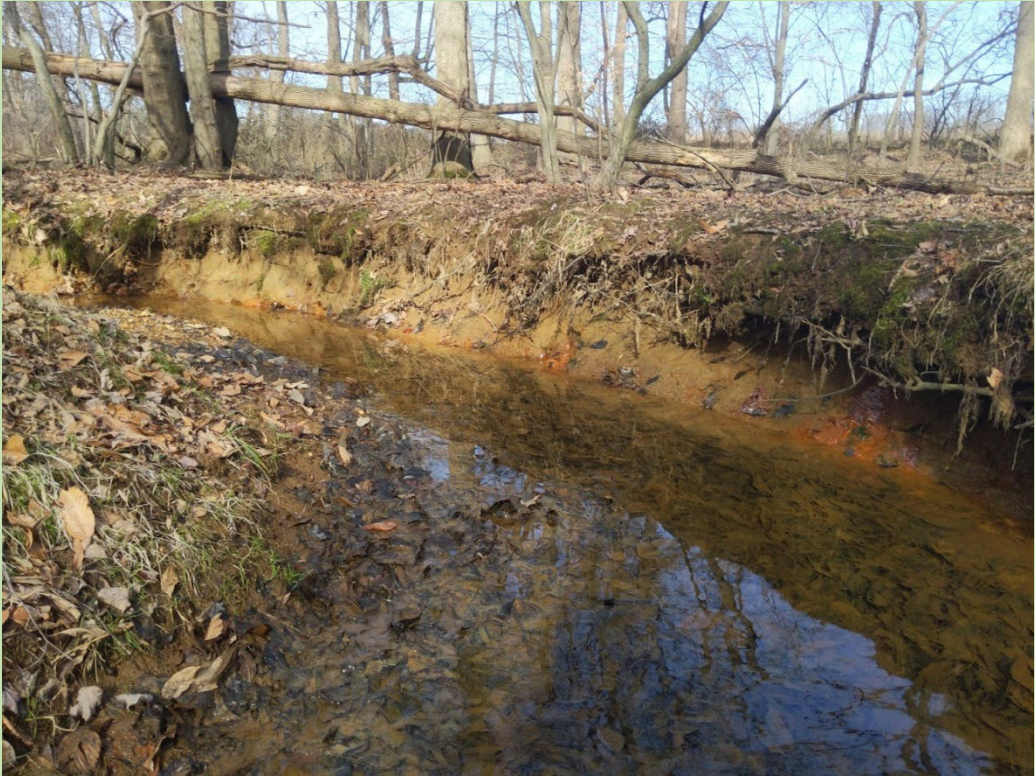
**Eroding Outer meander bend**

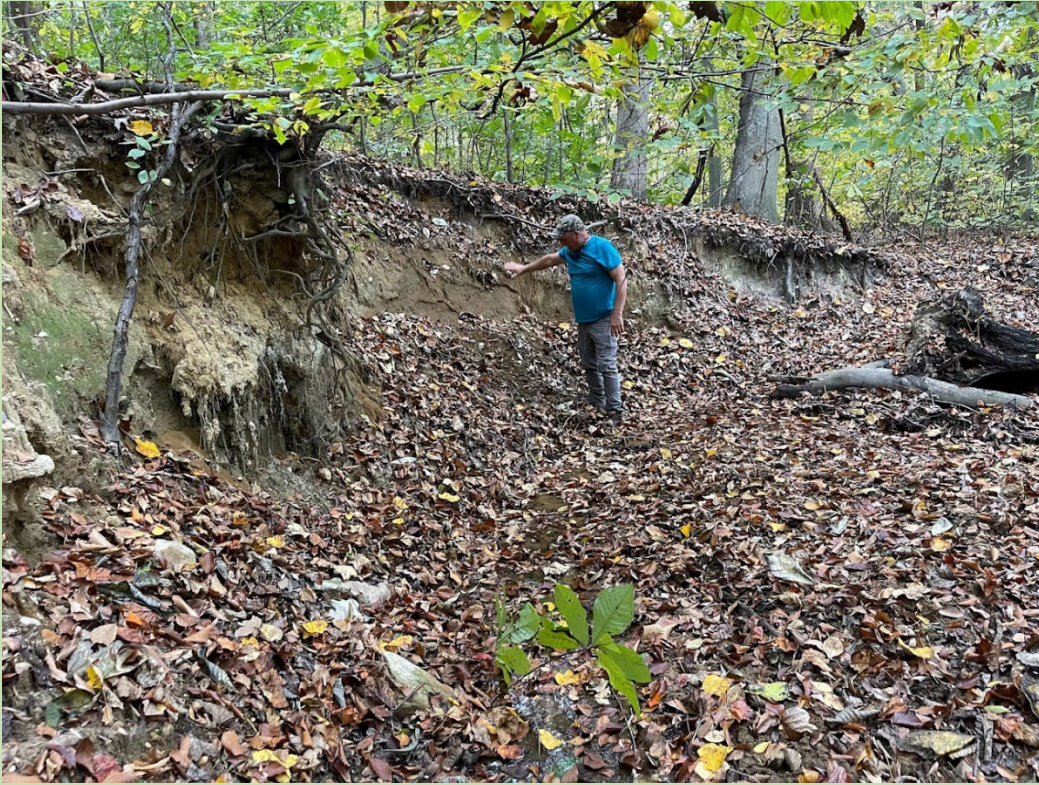
**Eroding stream bank- 6.5 ft bank height**

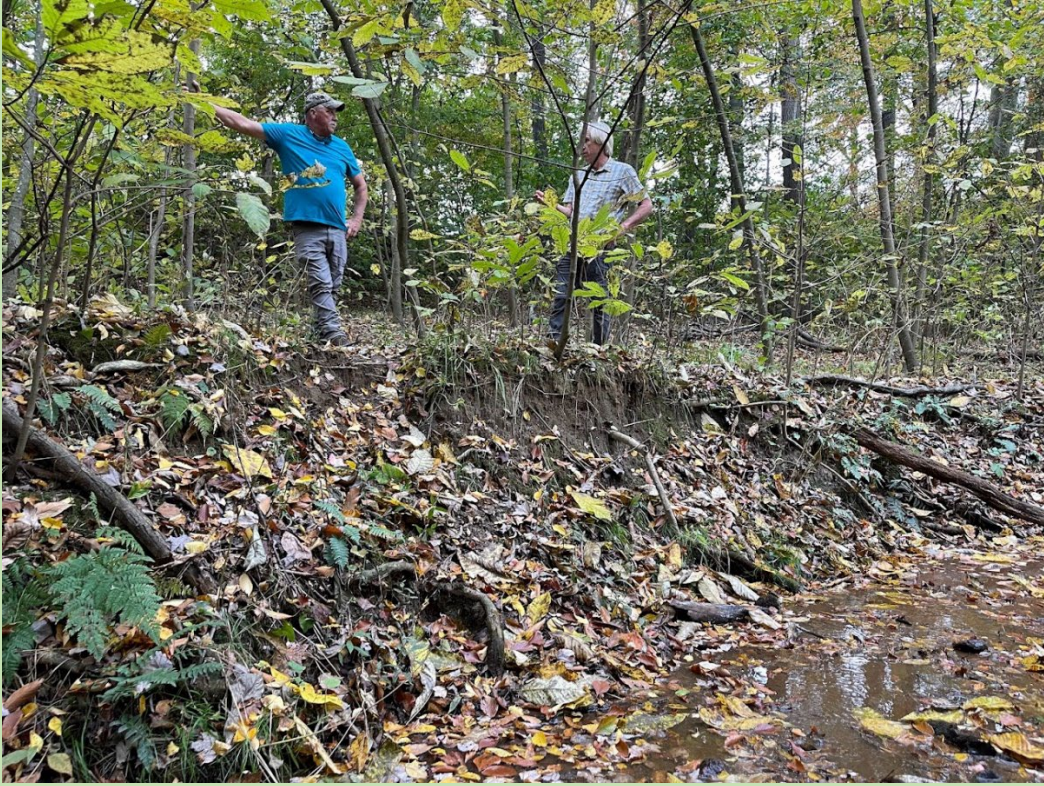
Typical eroding bank in Pawpaw stand

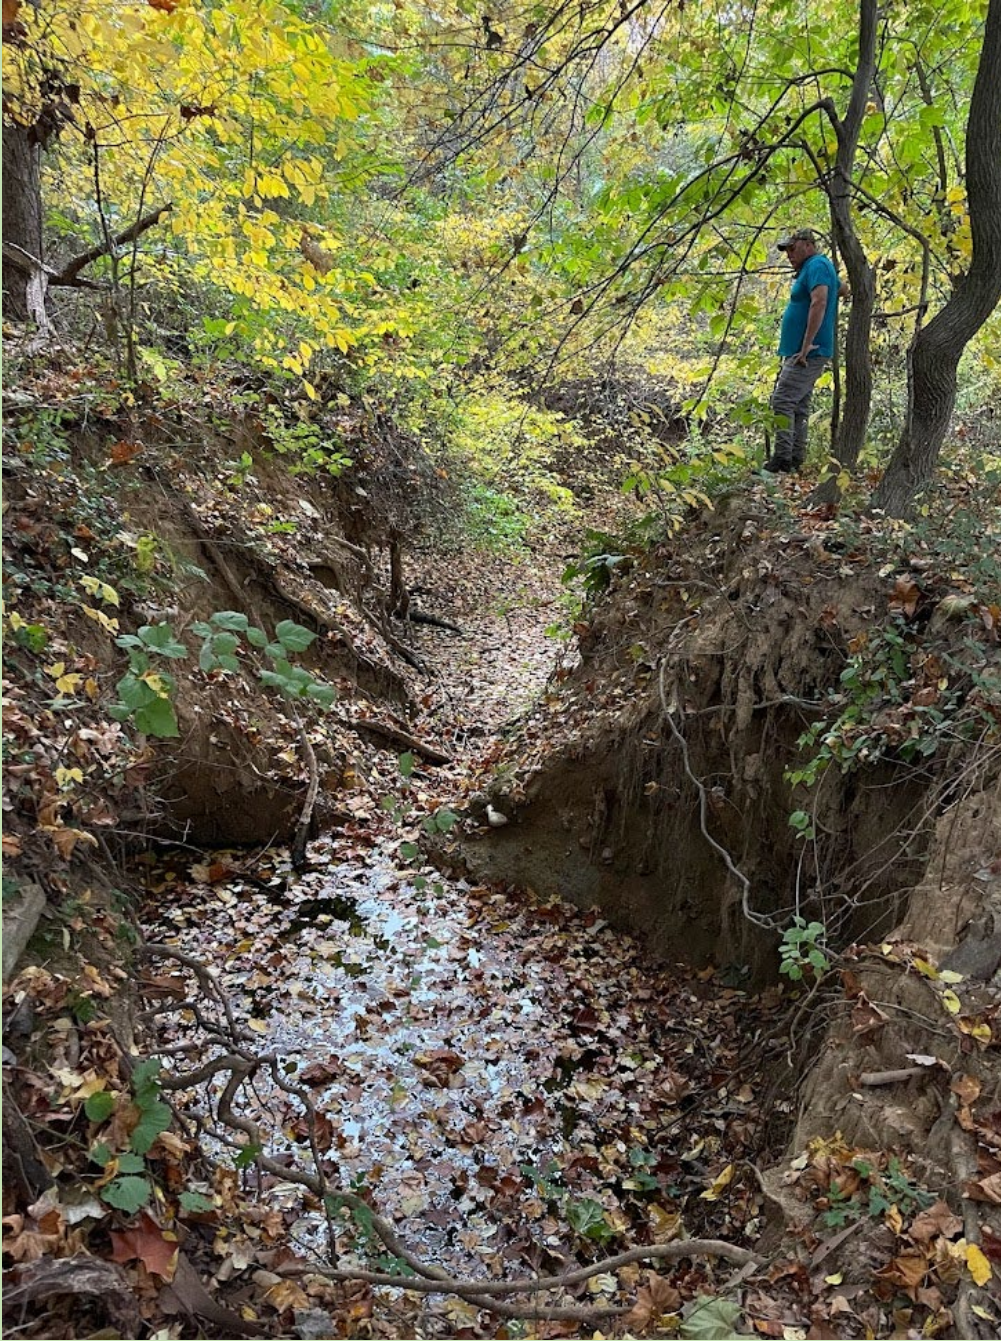
Ravine headcut at Site G

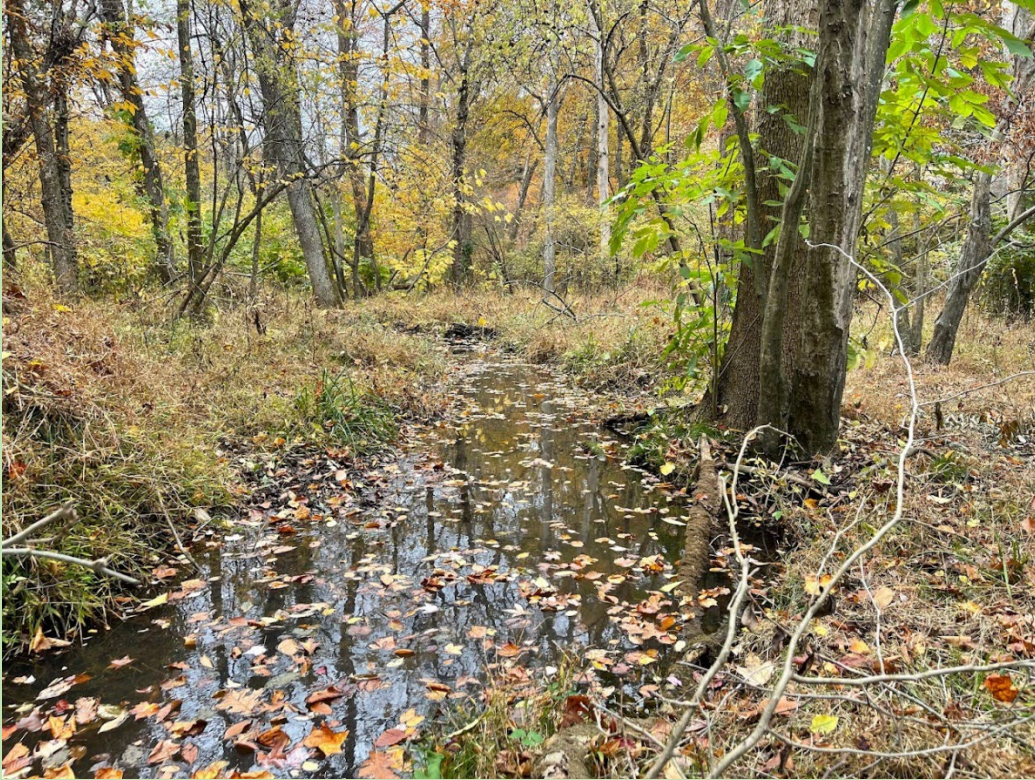
Stable reference reach on Cecilton Farm

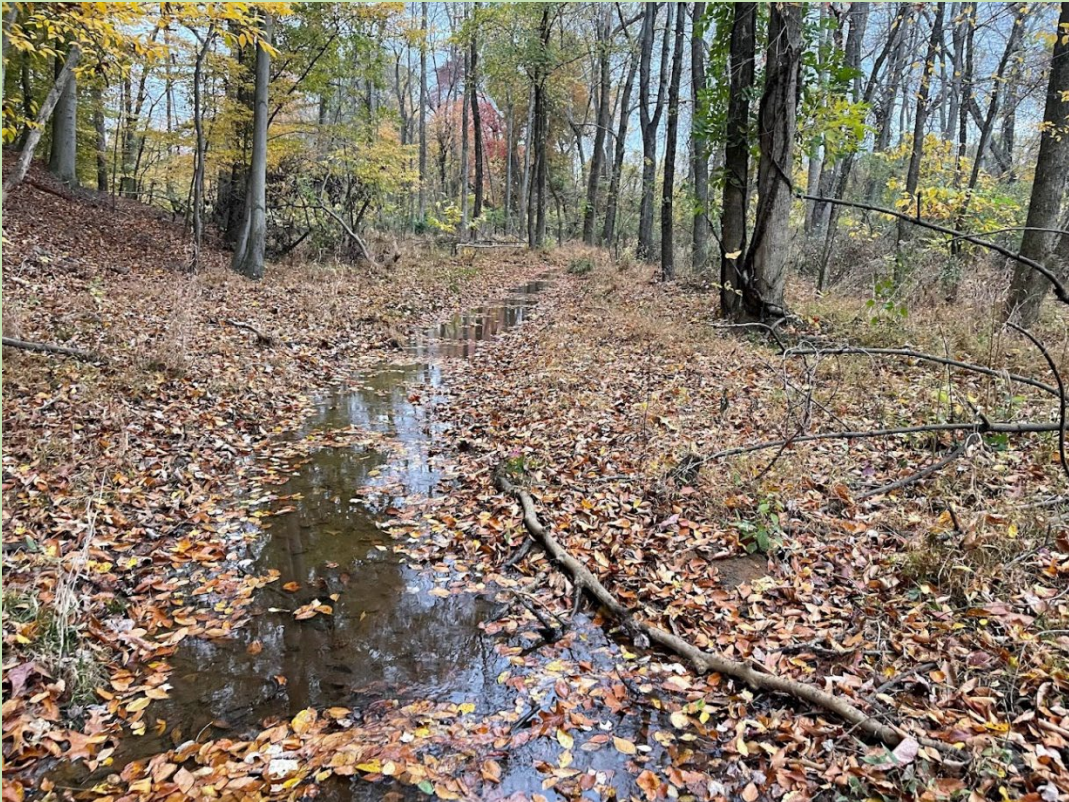
Stable reference reach on Cecilton farm

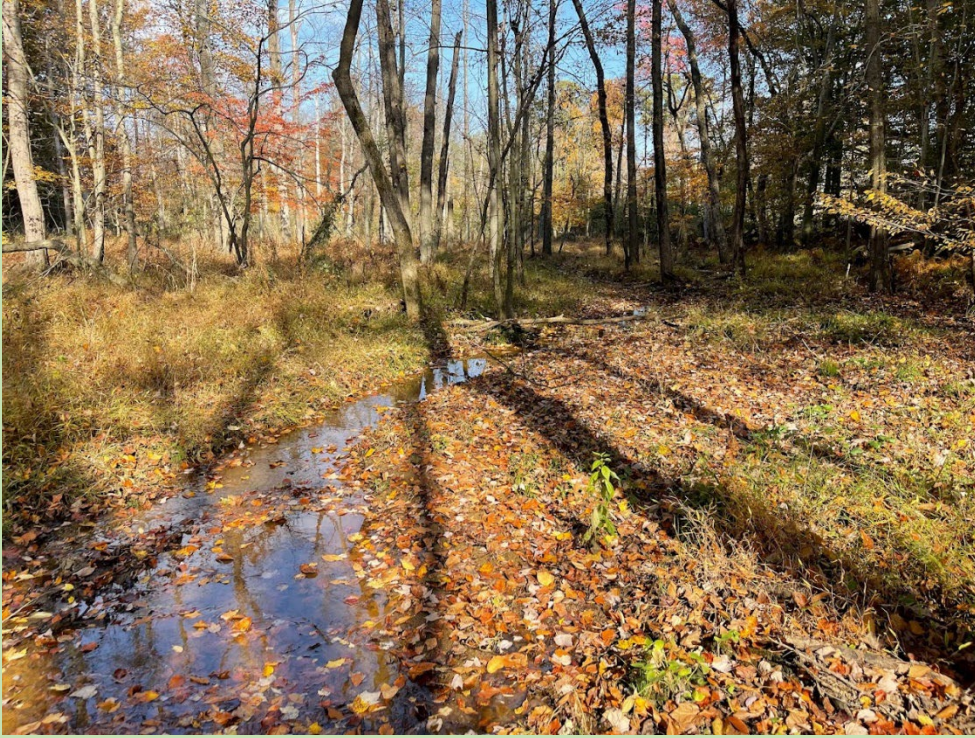
Stable reference reach on Cecilton farm

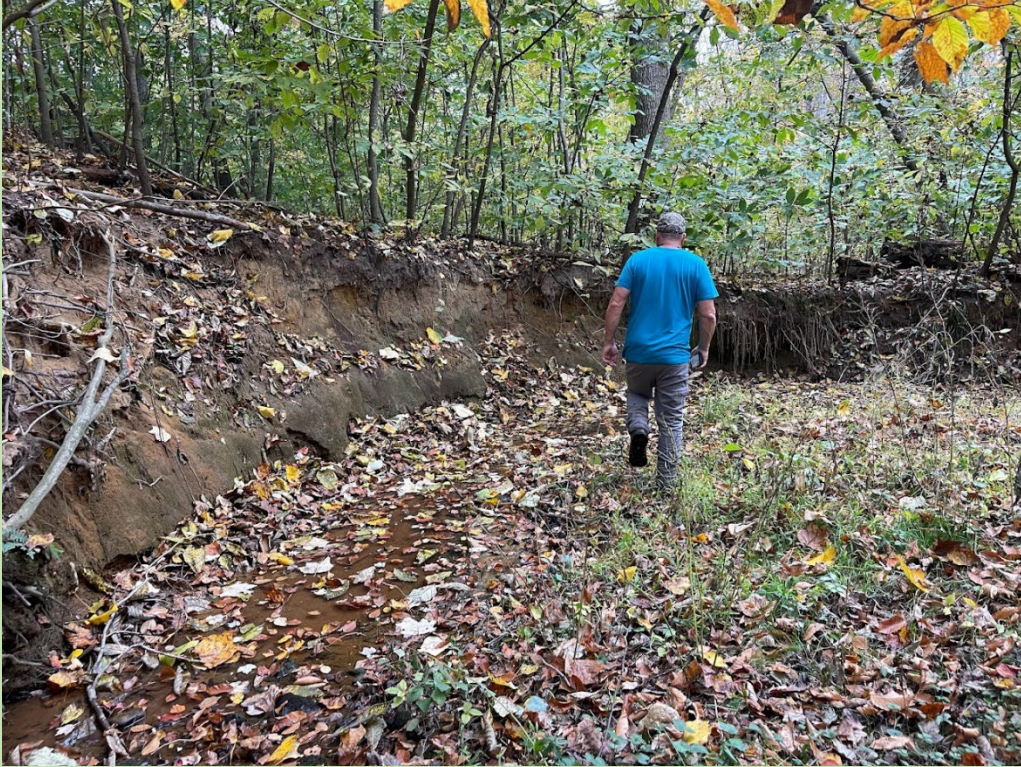
Looking downstream – Site D stream below wetland project installed in 2020

*Site D:* This 1,200-foot reach is typical of many forested ravines on the upper Eastern Shore, characterized by a severely degraded, incised, and overly widened condition, with heavy sedimentation, embedded substrate, and poor macroinvertebrate habitat throughout the system. Actively eroding streambanks, devoid of vegetation, and exposed, undercut root systems are typical throughout this stream. Severe outer meander bend geometry against highly erodible soils has caused collapsing ravine slopes through the upper reach. The lower system is surrounded by significant floodplain, but is disconnected through a combination of a legacy sediment deposits and incision of the stream channel due to erosive energy during storm events.

*Site D Approach:* As part of a strategic plan for the Cecilton Farm, the design team has phased the extensive work needed in a way that will allow balanced earthwork across the site, pairing this site's need for significant fill material with the excess cut material that sites C and B will likely produce. The design for this reach will incorporate a regenerative stormwater conveyance (RSC) step pool system within the upper steep section, tying into a single channel design in the middle reach as the valley widens out into a broader floodplain. The middle section will incorporate some valley cut, and incorporate material from the adjacent sites (if the material is appropriate) to bring the channel to within 0.5' of the floodplain elevation.

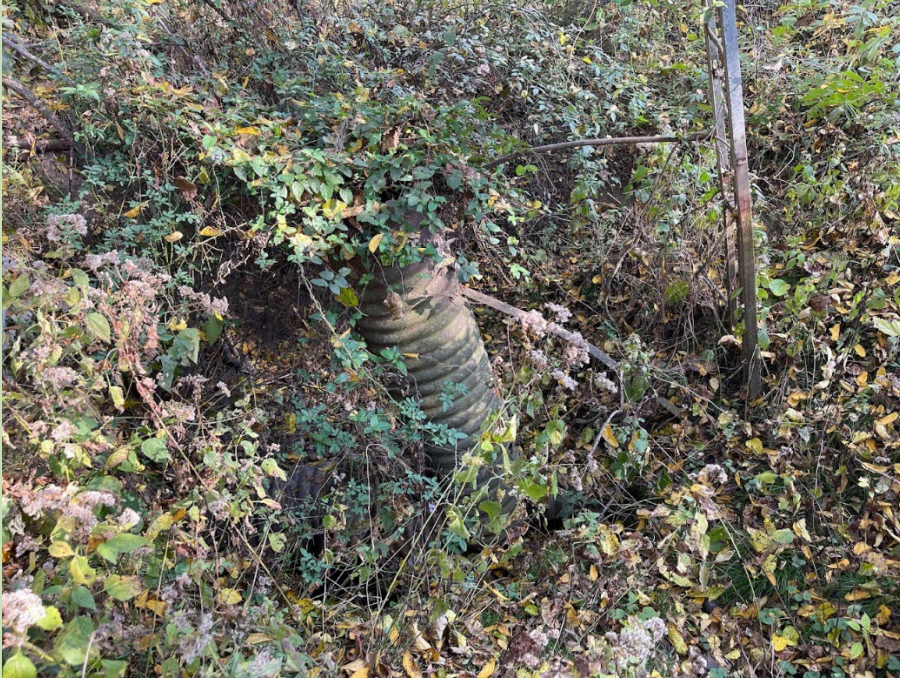
Site B- failed primary control structure in-stream at failing historical berm installed in 60s or 70s.

**Site B:** This site is downstream of the largest upland wetland practices and will have the greatest impact of the three proposed reaches. The upper 1,000 feet of this reach is a historic pond installed in the mid 1900s (no record at the Conservation District of the practice) by running a large berm across the stream valley and installing a primary spillway overflow pipe to control water levels. There was an emergency spillway installed on the south side of the pond that spills into the perennial stream below. Over multiple decades, this pond had filled with sediment and gradually grown in with scrub/shrub trees. The primary spillway pipe has failed, collapsing into a large sink hole, and the berm is failing at both the primary spillway and the emergency spillway—both are actively headcutting upstream into the historic sediment deposit in the pond basin. Within the basin, water flow moving through the failed primary spillway has formed a channel that is entrenched below the basin floor, acting as a stream channel that is disconnected from its floodplain and exacerbating the erosion and transport of sediment out of the pond and into the downstream floodplain of Black Duck Creek. Downstream of the berm, the primary spillway pipe is perched approximately 8 feet above the eroded stream channel below, and bank

*Site B Approach:* The approach in this reach will be to remove the failed berm and excavate legacy sediment deposited in the pond basin in order to restore the full stream length to tie into the upstream constructed wetlands. Total sediment cut depth will be calculated within the design, but the team will consider reaching a stable and balanced stream valley slope from the existing wetlands to the tie-in point at Black Duck Creek, and may use a cascade or log step grade control to cascade the outflow of the wetlands to the proposed stream valley elevation. The design team will also work toward a balanced cut/fill for the overall Cecilton farm site, and any material removed will be transported to Site D for channel fill material. Downstream of the existing berm, the right side of the valley will be excavated to lower to the stable stream bed on the left valley wall. Cross valley grade control will be installed, and the entire reach will be planted with wetland tolerant shrub species and emergent plugs.

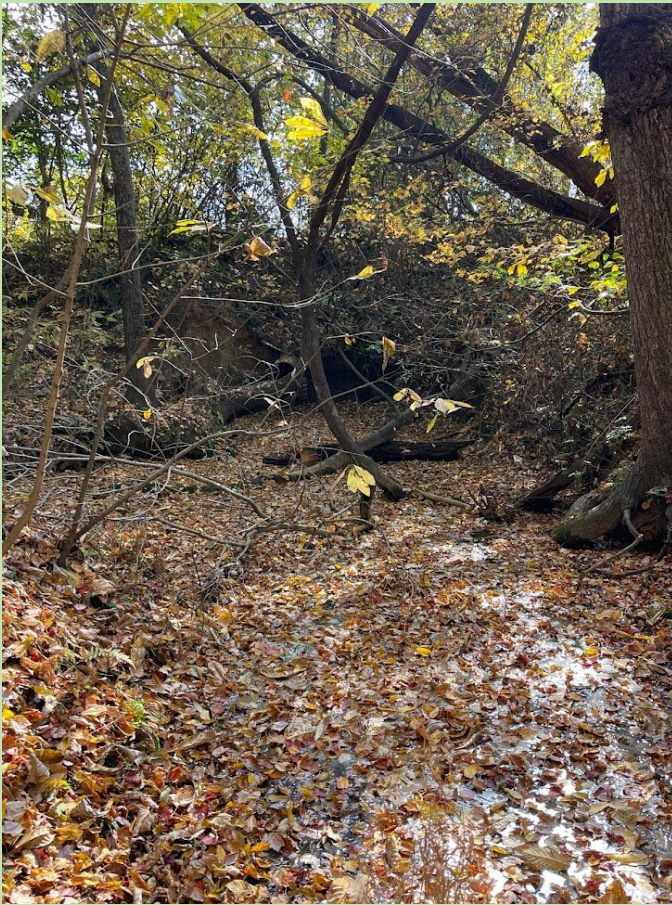
Looking upstream at back of historical berm that is blown out – Site B

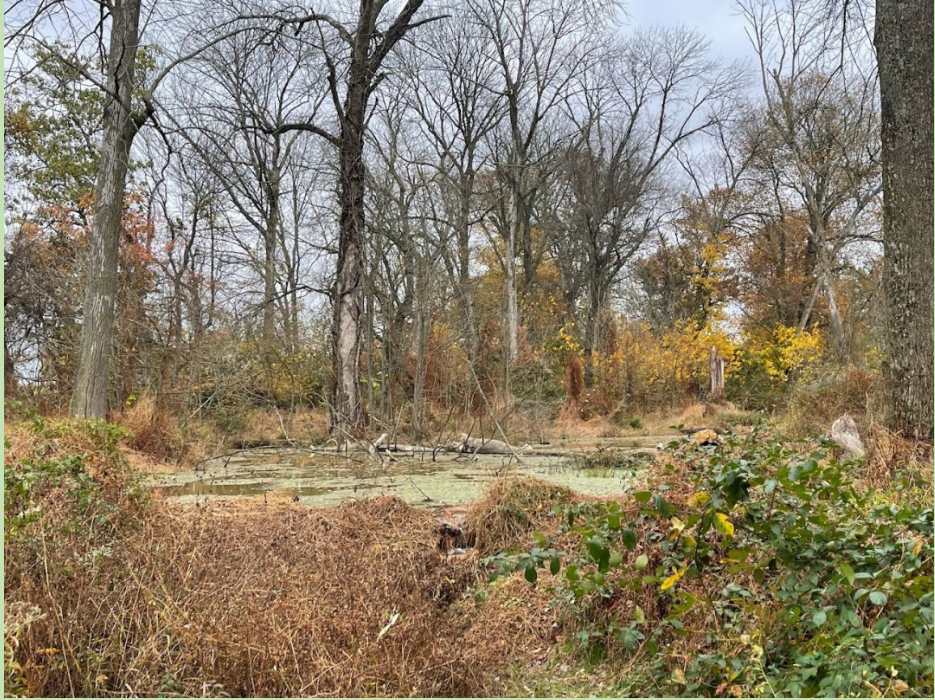
Looking upstream at abandoned beaver pond in stream valley C

*Site C:* This reach is relatively short, totaling 700 feet from the constructed wetlands upstream to a stable point downstream at Black Duck Creek. There is an abandoned beaver dam near the downstream end of the reach and is currently beginning to destabilize and lose sediment stored in the upstream ponded area. There is approximately 0.5 acres of wetland habitat created by the beaver dam that will be lost when the dam fully breeches, along with the significant sediment stored in the upstream ponded area. Upstream of the abandoned beaver dam influence, the stream channel quickly becomes entrenched as the valley gains elevation, with 5–7-foot banks and a fully disconnected floodplain near the upstream wetland outfall. The stream valley is dominated by immature, invasive trees and shrubs.

*Site C Approach:* The approach proposed in this reach is to stabilize the existing wetland habitat created by the abandoned beaver dam by installing a permanent structure across the floodplain to hold the existing water levels and install a stable log step pool structure to safely convey overflow to the downstream streambed elevation. Upstream of the abandoned beaver dam influence, the team will balance floodplain cut and channel fill activity on 700 linear feet of stream valley, and work toward a stable valley slope and stream morphology until tie in with the water elevation at the stabilized abandoned beaver dam. The work in this reach will prioritize undersized bankfull elevation and promoting floodplain access, as well as floodplain grading to create shallow wetland habitat throughout. Cross valley grade control will be installed to prevent downcutting of the channel.

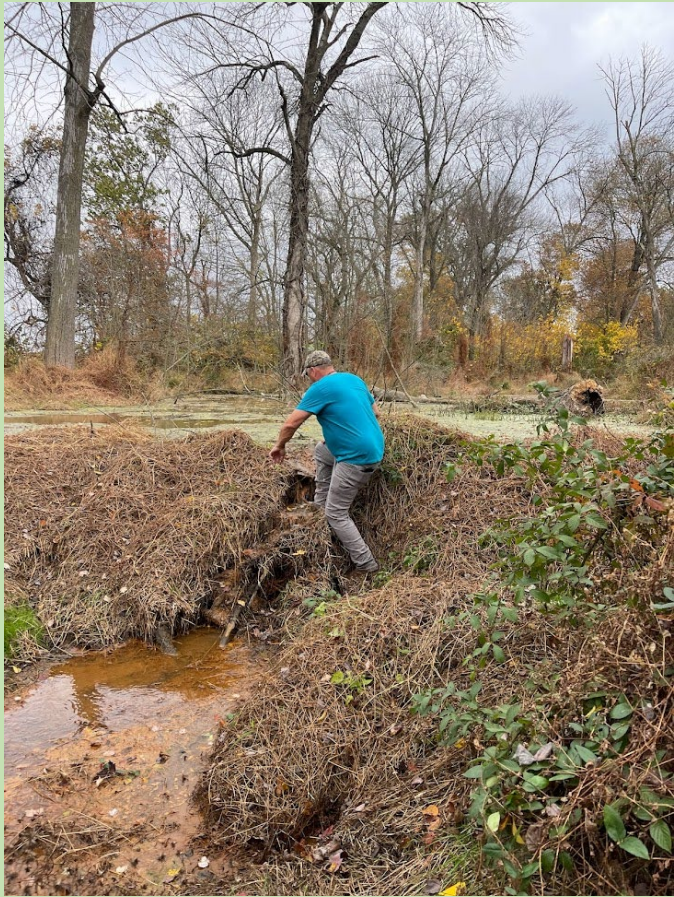
Point of failure forming on abandoned beaver dam

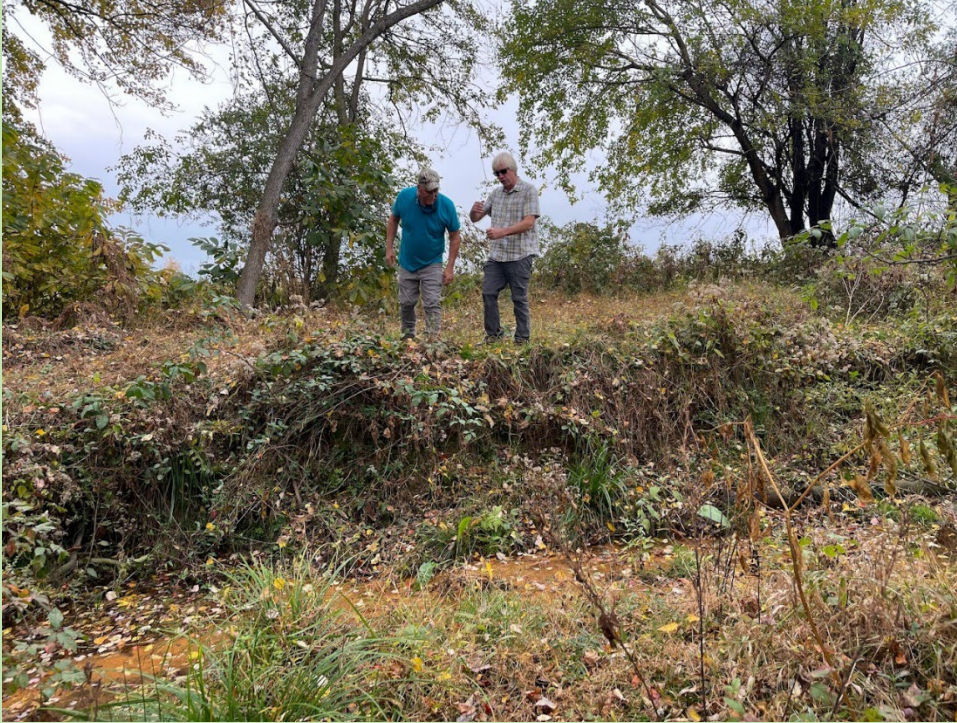
Typical entrenched bank condition and open floodplain upstream of beaver influence

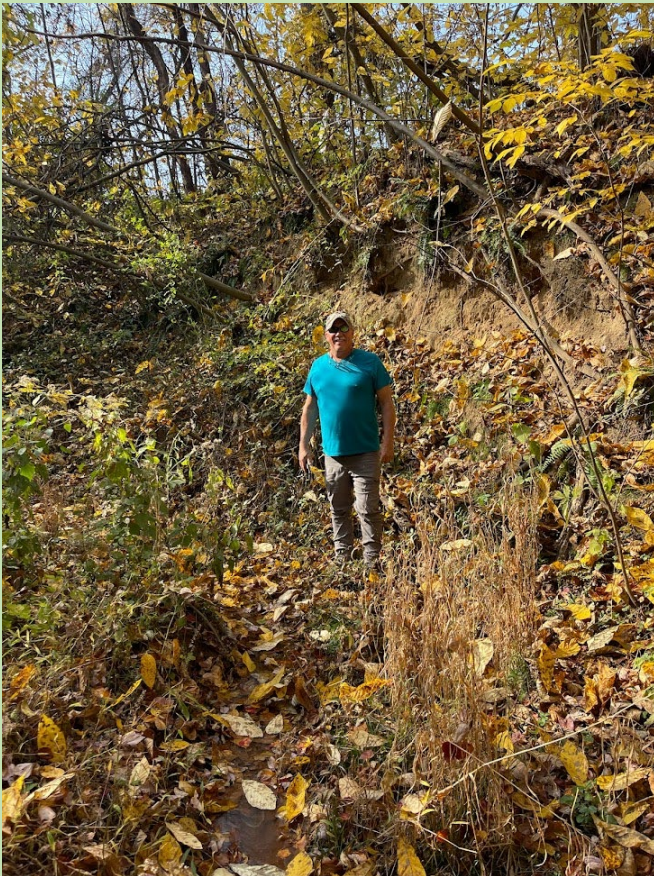
Headcut migrating into field edge – site B

height is 8–10 feet. There are two large, active headcuts migrating south into the field adjacent to the floodplain. There is also approximately 300 feet of perennial stream from the berm to a stable grade at the convergence with Black Duck Creek: this reach is entrenched and over widened to approximately half of the total floodplain width.

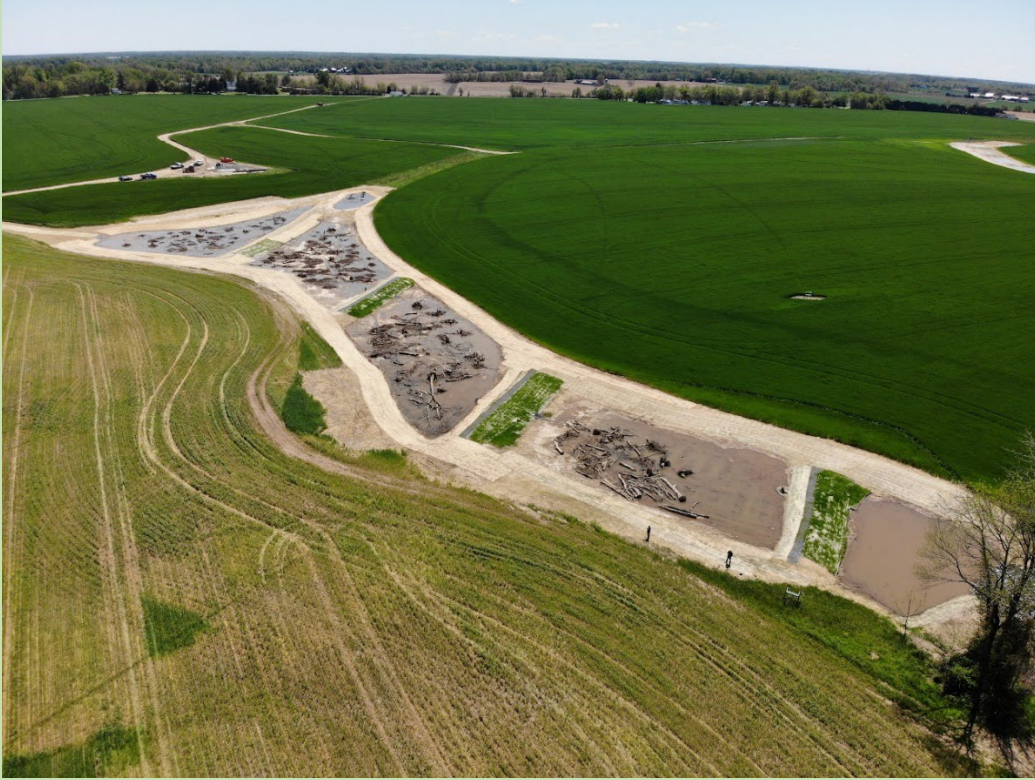
Wetlands being constructed upstream of project site A, B, C, and D in 2020
