Poor House Run Hydrologic Assessment and Watershed Action Plan

April 1, 2022

Appendix E: Constructability Analy	ysis

POORHOUSE RUN STREAM RESTORATION CONSTRUCTION FEASIBILITY REPORT

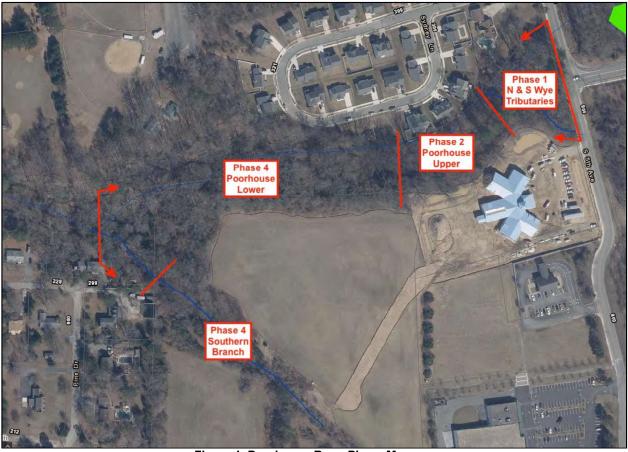
Figure 1. Poorhouse Run - Phase Map

In an effort to organize the analysis, the project was split into sections to represent the most logical or likely construction phases. The phases are not prioritized by restoration need or in any sort of implementation order, but are separated by logical access and staging. These phases are shown below in Figure 1.

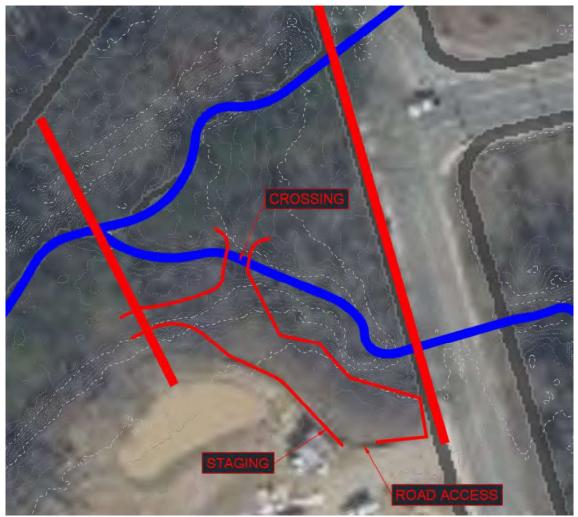
Figure 2. Phase 1 Access / Staging Map

Once staging access is obtained, access to the floodplain can be achieved by traversing along the backside of the existing stormwater BMP's and descending down to the lower extent of the South Wye Tributary. From this point, equipment would have to cross the stream channel. While a temporary bridge could be used in this instance, it would just more economical to pump baseflow during construction and simply cross the existing stream channel. The Figure below outlines the general road access, staging and floodplain access locations. This road access and staging would also be an option for Phase 2 work as well.

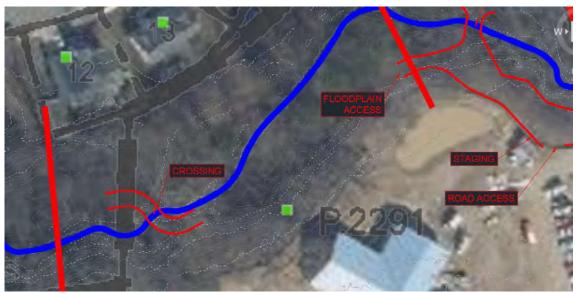
Figure 3. Phase 2 Access / Staging Map

Once staging access is obtained, access to the floodplain can be achieved by traversing along the backside of the existing stormwater BMP's and descending down to the lower extent of the South Wye Tributary, passing the Phase 1 crossing. From this point, equipment would have to travel on the left floodplain of Poorhouse Run to access the stream channel / work areas. Load protection matting would be needed in saturated areas along the toe of slope. Additionally, the BMP outlets would need to remain operational and unobstructed during construction. A crossing would need to be installed to access the right bank on the downstream most extent of the project phase. This crossing could alternatively be used to access Phase 2 from Phase 3 or vice versa. The Figure below outlines the general road access, staging and floodplain access locations.

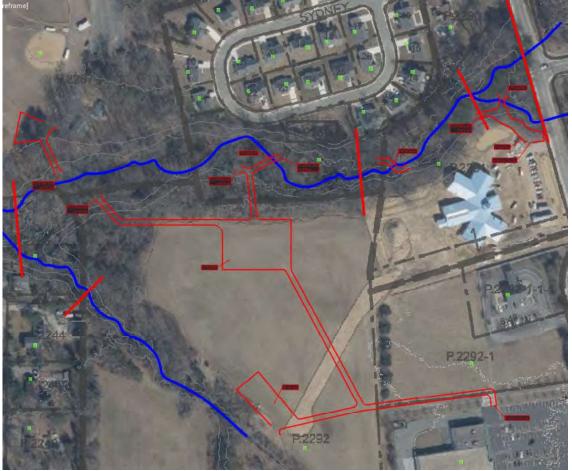
Figure 4. Phase 3 - Overall Access / Staging Map

Once staging access is obtained, access to the floodplain can be achieved by traversing at a few select points on the left bank of Poorhouse Run. Each of the identified locations would provide adequate access to the floodplain. If access from the Lions Park was used, as few as (1) stream crossing would be needed to address the entirtey of Phase 3. Due to varying ground conditions, the use of timber load protection matting is likely required in some floodplain locations. Detailed locations of the haul road depend on the restoration design as well as a detailed topographic survey of the channel and floodplain. The figure(s) below outlines the general road access, staging and floodplain access locations.

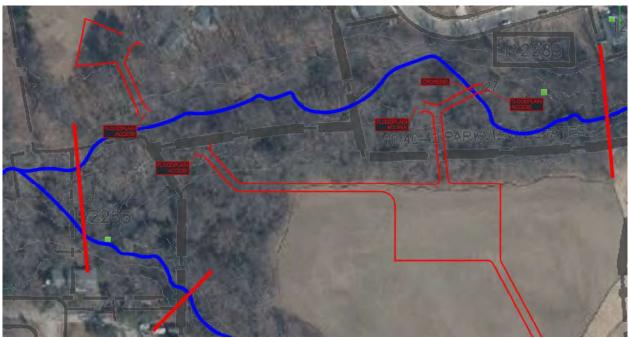
Figure 5. Phase 3 Staging and Access Points

Phase 3 has a multitude of possible staging locations due to it's proximity to a park / playing field. Ideally, on-road truck access would be made available the whole way to the tree line at the southern edge of Poorhouse Run. This would reduce the need for heavy equipment to travel back and forth to the main road access point. A central staging area is preferred as shown on the figure below. Additionally, a staging area can be used on the south side of the baseball field at Lions Park with limited impact to the park or forest surrounding. This staging area would be ideal for work on the north floodplain if necessary.
